June 7, 2023

> Subject: DNR Review of Interim & Remedial Action Status at

> > Community Within the Corridor - East Block 2748 N. 32nd Street, Milwaukee, WI 53210 BRRTS #02-41-263675, FID #241025400

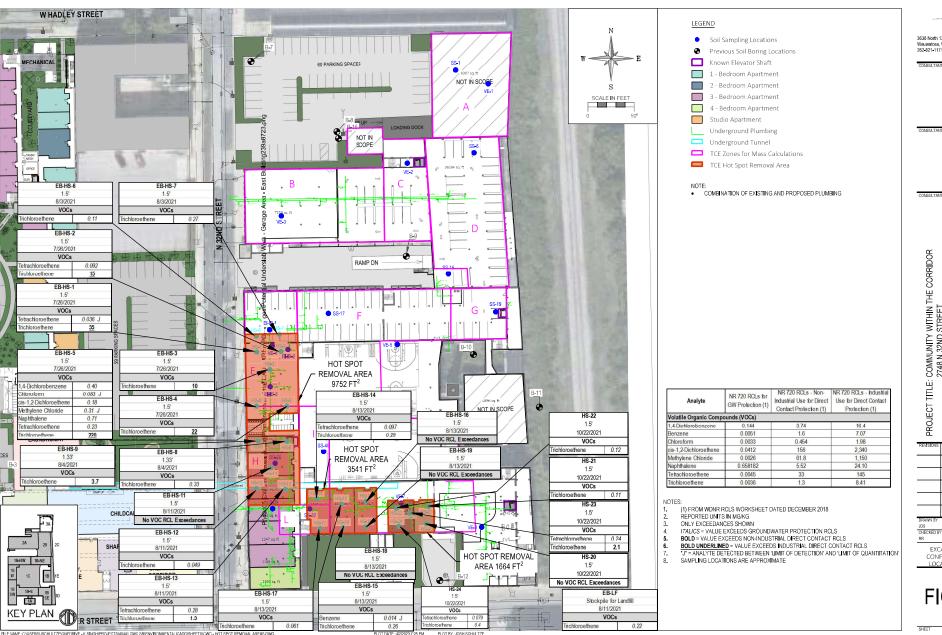
# FIGURE 4

- On April 7, 2023, CWC submitted *Interim Remedial Action Documentation Report* (April 2023 Report) to the DNR. The April 2023 Report indicated that in August 2021, approximately 1,765 tons of contaminated soil was removed from beneath Building 1B, as shown on Figure 4 of the April 2023 Report (attached).
- CWC's Status Reports have provided information on the corrective actions that have been or are being
  implemented at the building complex. At this time, the actions are focused on modifying the VMS and
  sealing preferential pathways where contaminated vapors may be entering the building complex. CWC is
  taking these steps because the VMS is not currently functioning as intended. Because SVE is a
  component of the site's VMS, it appears based on the information provided by CWC that the SVE is also
  not occurring as intended.

The highest concentration of TCE identified in soil during CWC's site investigation (pre-soil excavation) was at sample location EB-B-29, with TCE at 87 mg/kg from 2-4 feet below the building's slab. This sample location is within Building 1B, which is where some of the highest concentrations of TCE soil contamination were identified during the site investigation. As presented in the April 2023 Report, the remedial soil excavation performed within Building 1B extended to 1.5 feet below the building's slab. Following soil excavation, CWC collected confirmation soil samples from the base of the excavation cavity (at 1.5 feet below the building's slab). The highest concentration of TCE identified in the confirmation samples collected within the remedial excavation limits was 220 mg/kg at sample location EB-HS-5. Several confirmation samples collected from within the remedial excavation limits and several soil samples that were not excavated (i.e., deeper than the excavation limits), such as EB-HS-5 and EB-B-29, indicate that a significant amount of soil contamination remains beneath Building 1B, which will likely act as a continuing source for potential vapor intrusion.

04/02/2023 EXCAVATION AREA WITH CONFIRMATORY SAMPLING LOCATIONS AND RESULTS
